CABLE REPLACEMENT INSTRUCTIONS

Cable/Sheave Replacement Procedure

For Drywall Lift Model 138-2

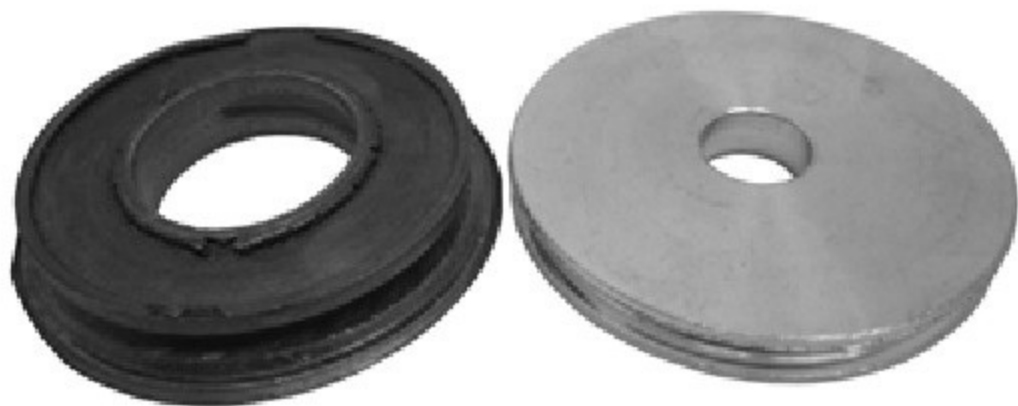
- Inspect the Sheaves (Pulleys) and follow the procedure at the right to replace when worn. Sheave (Pulley) wear can occur where the cable rides and on the axle. Make sure to inspect both. Sheave can either be brass or aluminium. The sheave on the left is badly worn on both the axle and cable groove. Sheave on right is a new sheave.

Inspect and replace sheaves (pulleys) before replacing the cable. There are 3 sheaves on the 138-2 Panellift®, one on the frame and two on the "B" telescoping section.

Sheaves should be solid on their axle and not move up and down or back and forth. To replace, remove cotter keys and discard old axle and sheave. Replace with new sheave, axle and new cotter keys.

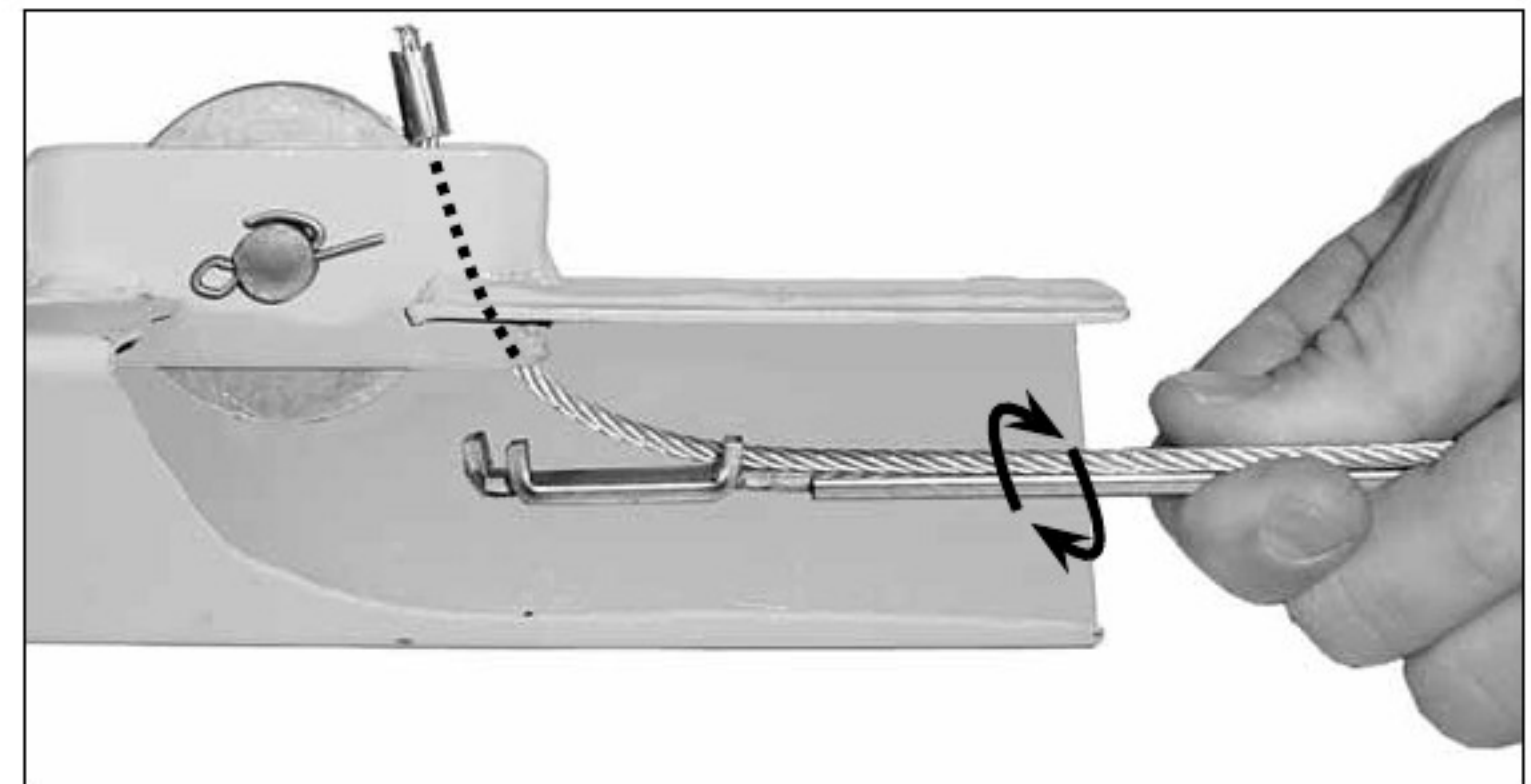
3b. With a clock-wise motion like that of tightening a screw driver, twist the cable installation tool while holding the crimped end of the cable up into the sheave pocket. The cable will pop loose from the tool and pop up through the sheave pocket as shown in this cut away view.
