# CABLE REPLACEMENT INSTRUCTIONS continued

## REINSTALLING the telescoping sections: PANELLIFT® Model 182

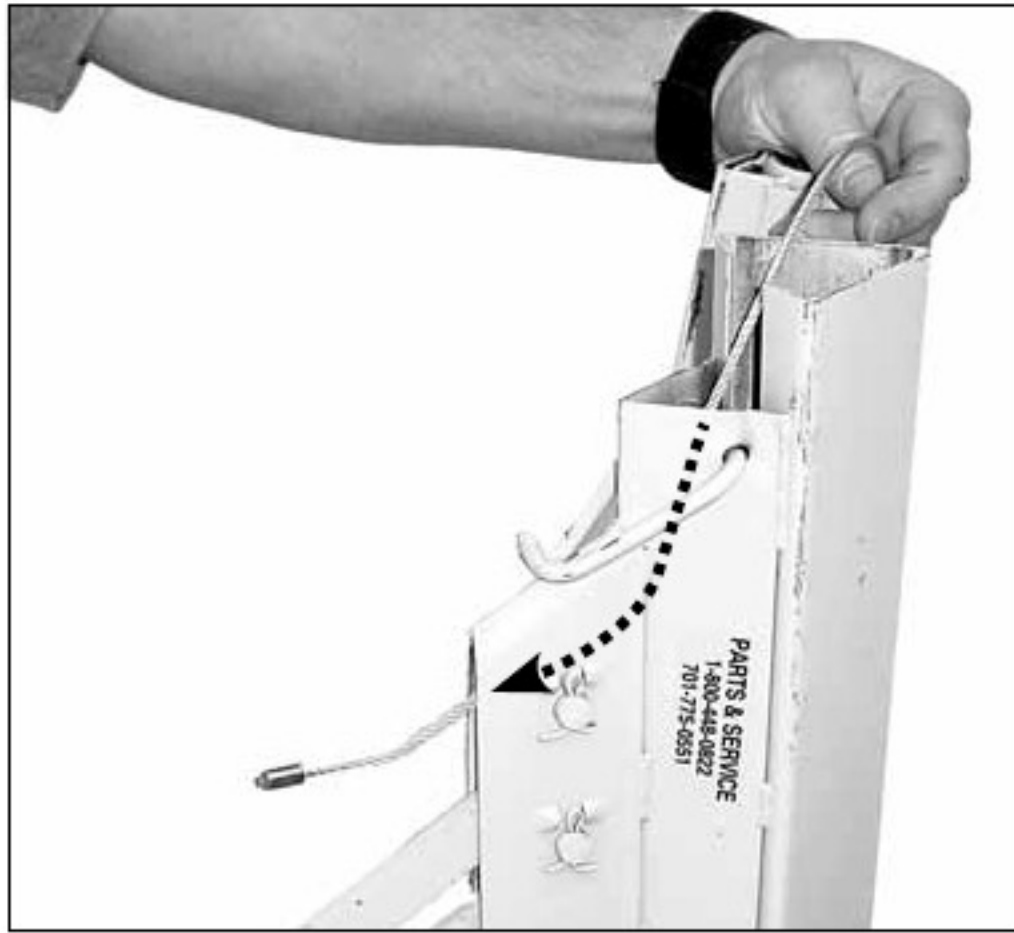
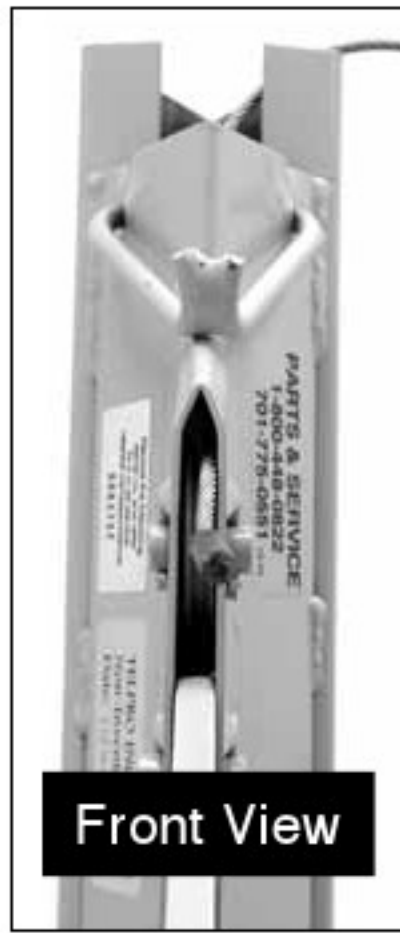
Front View

7. To reinstall the assembled telescoping sections, feed the crimped end of the cable through the frame sheave pocket from the top and over the top of the sheave as shown. (Model 182 go to page 13)

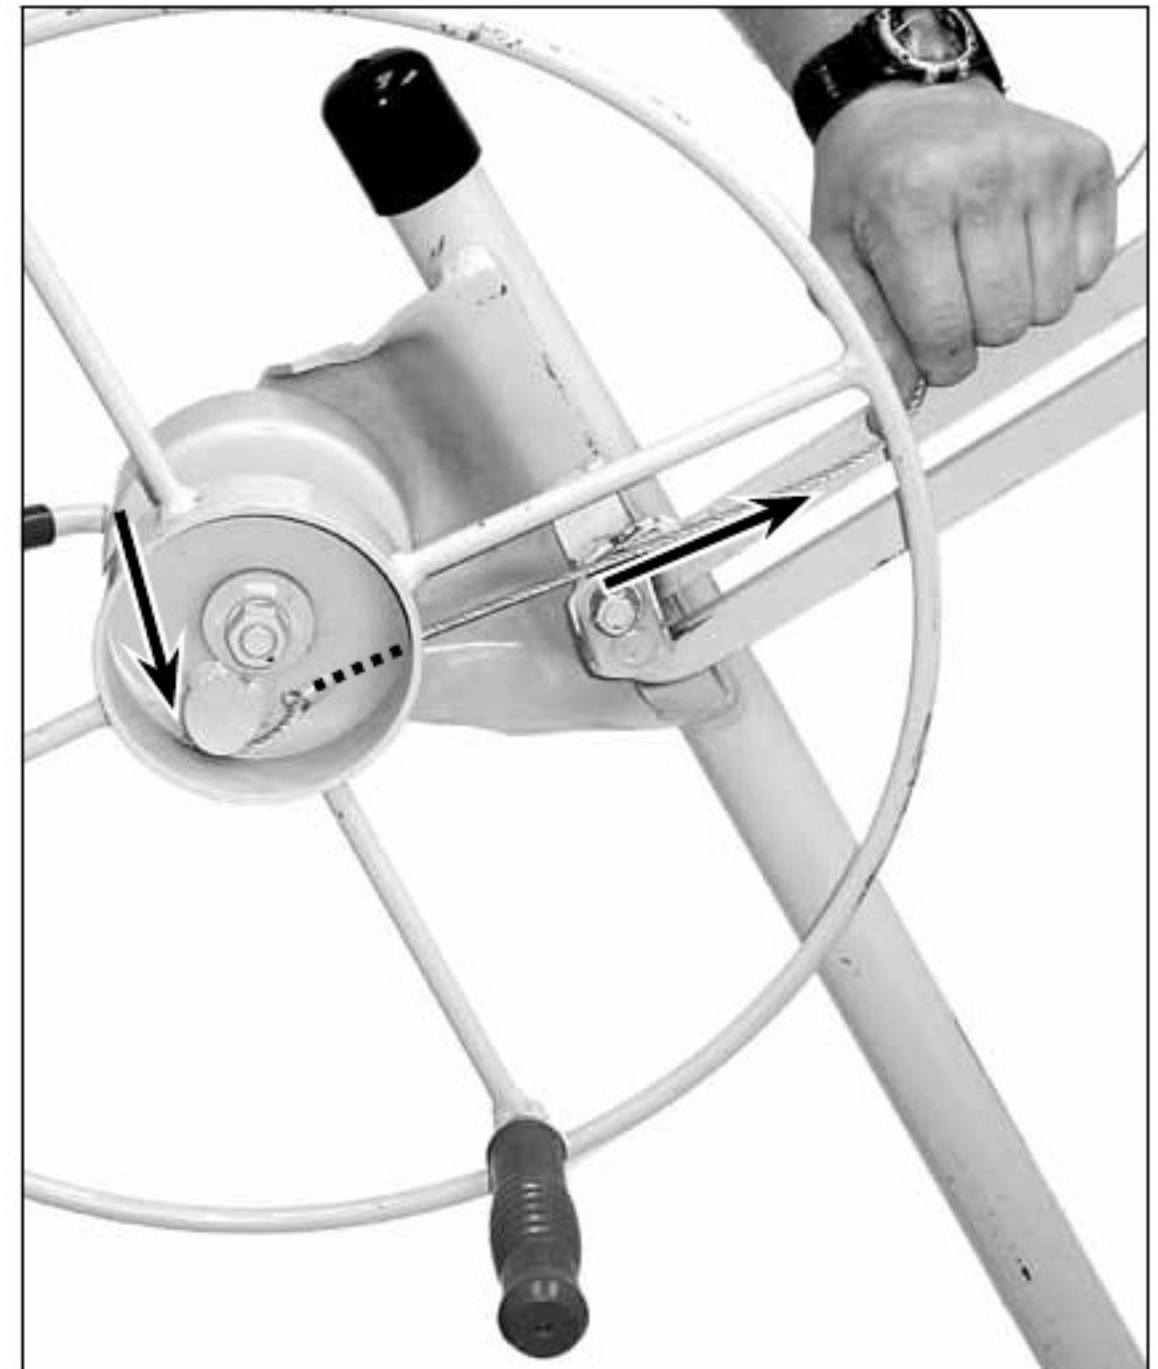
9. Feed the crimped end of the cable through the hole in the winch drum and secure it behind the mooring tab by hand pulling the cable snug as shown.

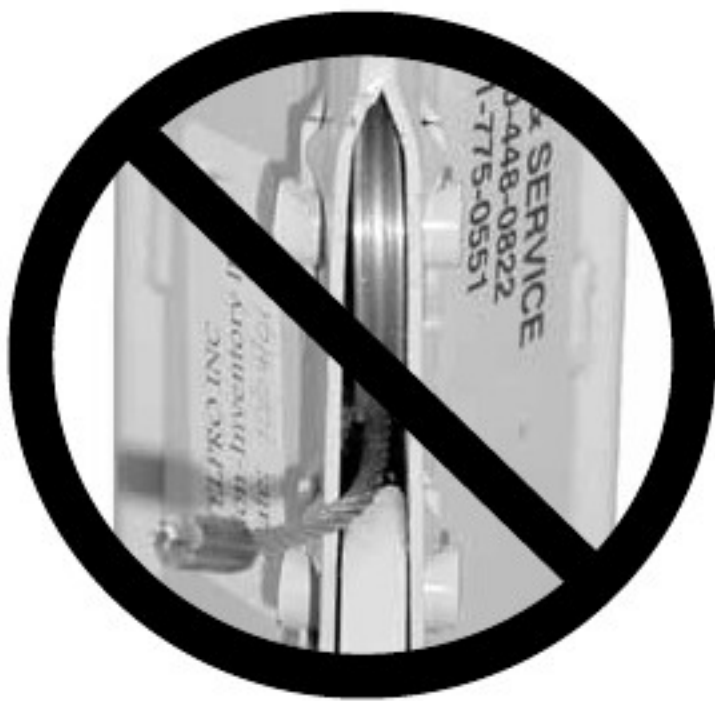
**DO NOT** feed the cable under the cable sheave on the frame as shown in this photo!

The cable **MUST** feed down from the top of the frame housing and over the top of the sheave exactly as shown in step 7 in order to function properly. Failure to install the cable correctly as shown can cause wearing of the cable for which it is not designed which can result in failure of the cable. Failure of the cable while the lift is raised will result in a sudden and rapid lowering of the lift and the load possibly resulting in serious property damage and / or serious bodily injury.

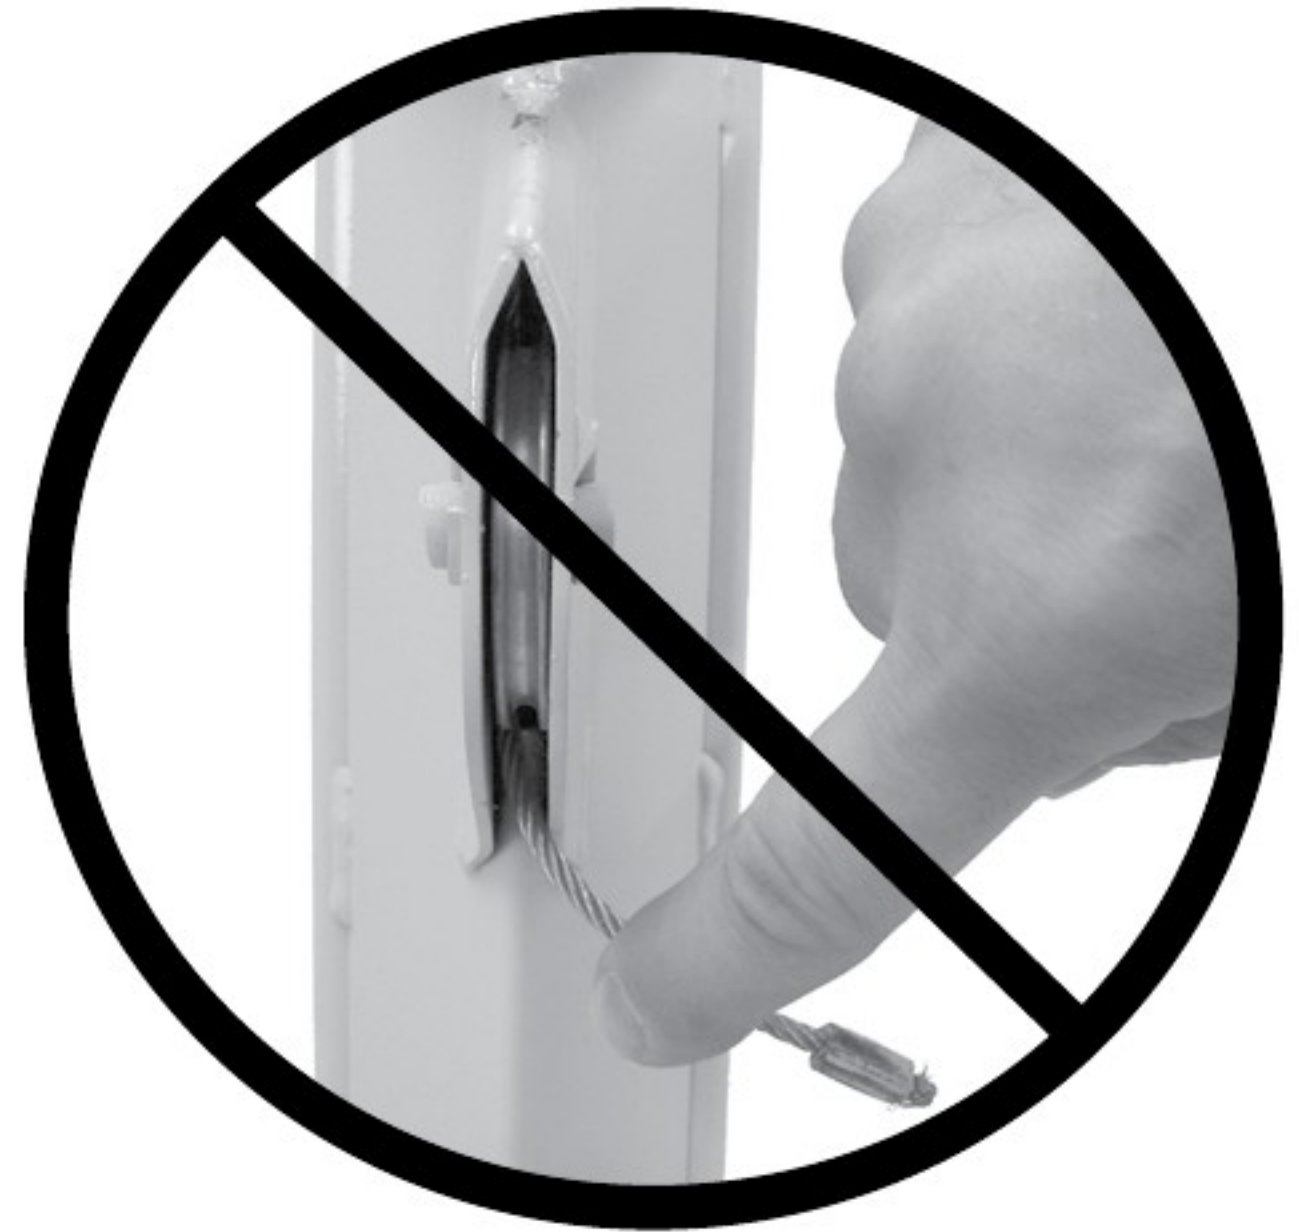
DO NOT feed the cable under the upper cable sheave on the frame as shown in this photo!

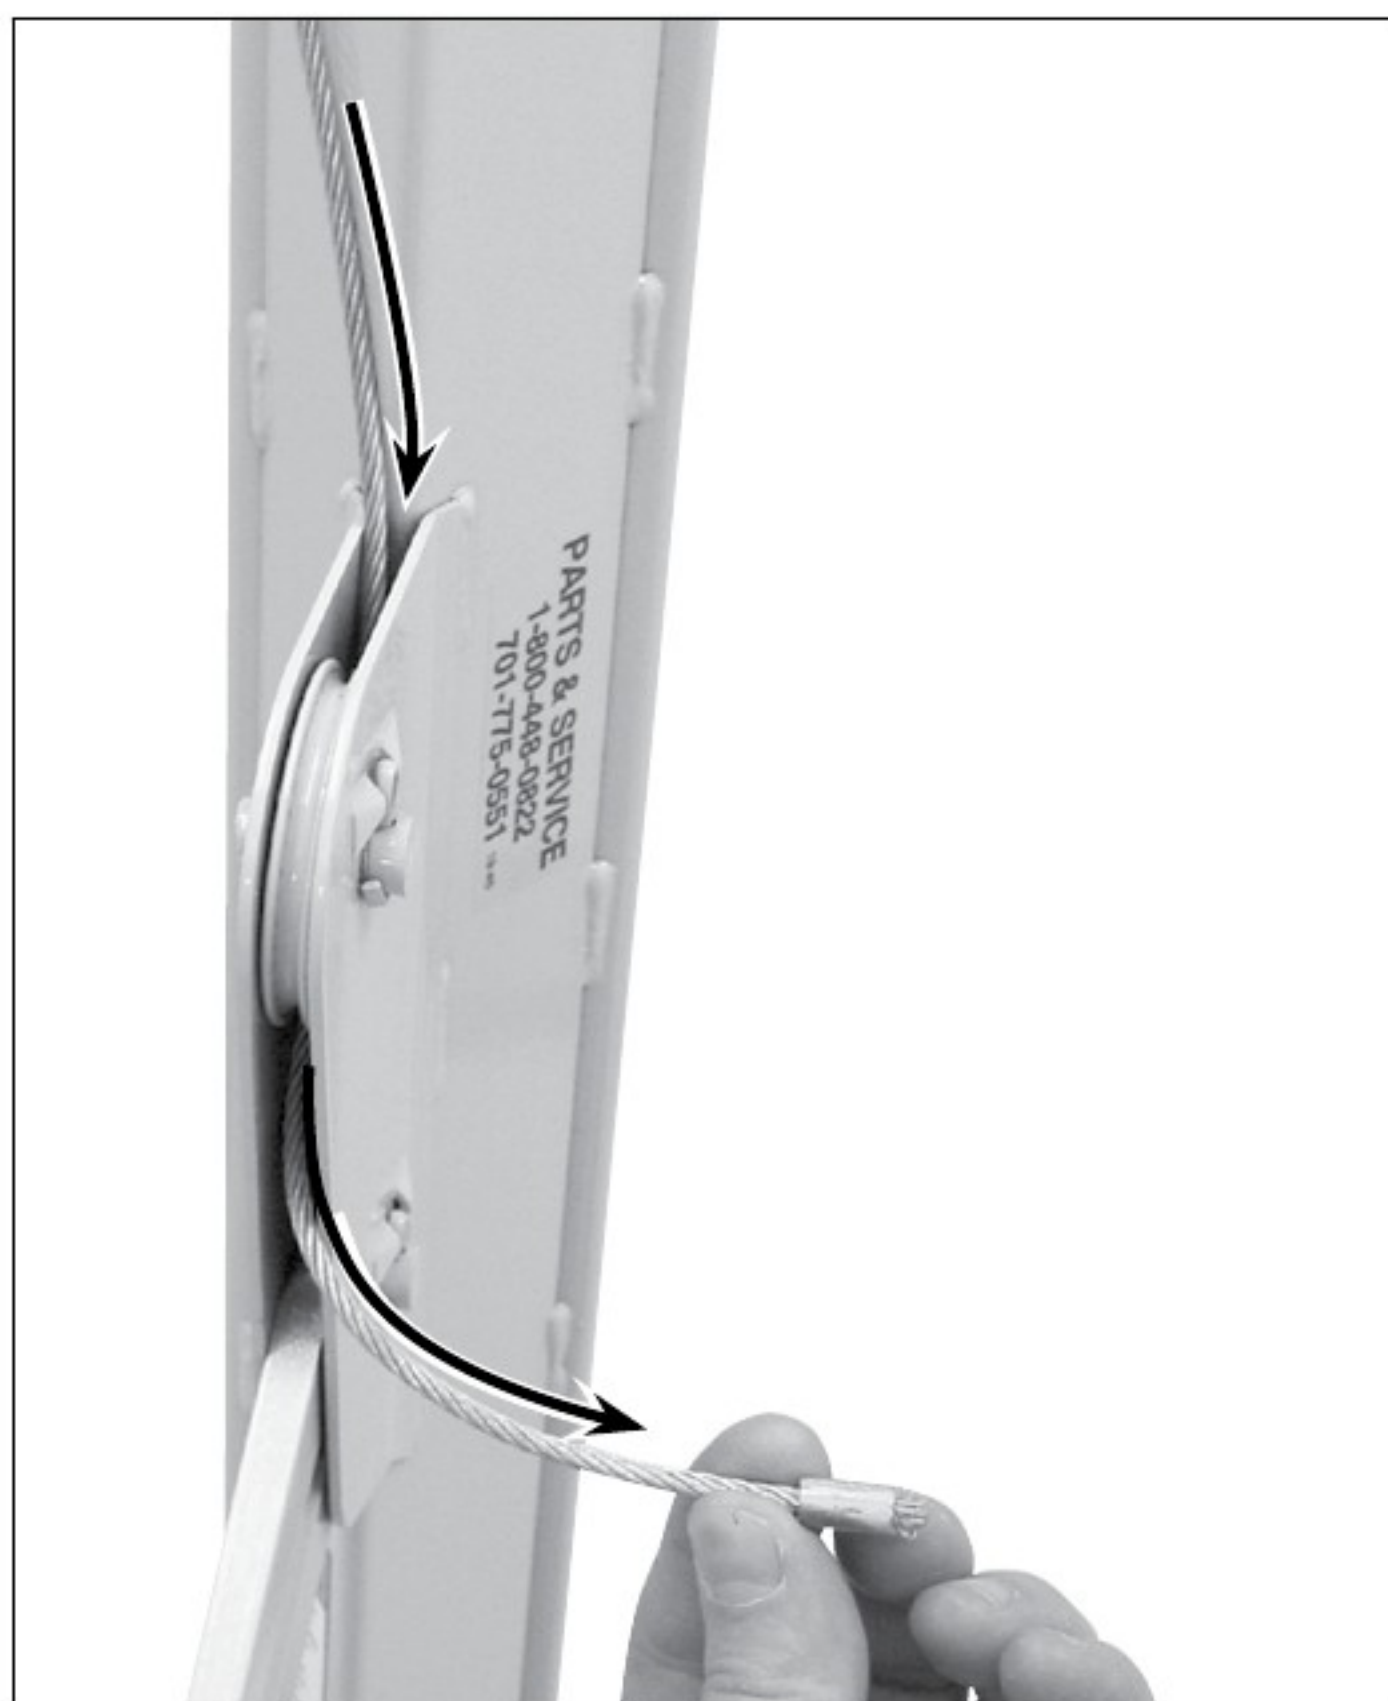
8a. Feed the crimped end of the cable through the lower frame sheave pocket from the top and out the bottom as shown.

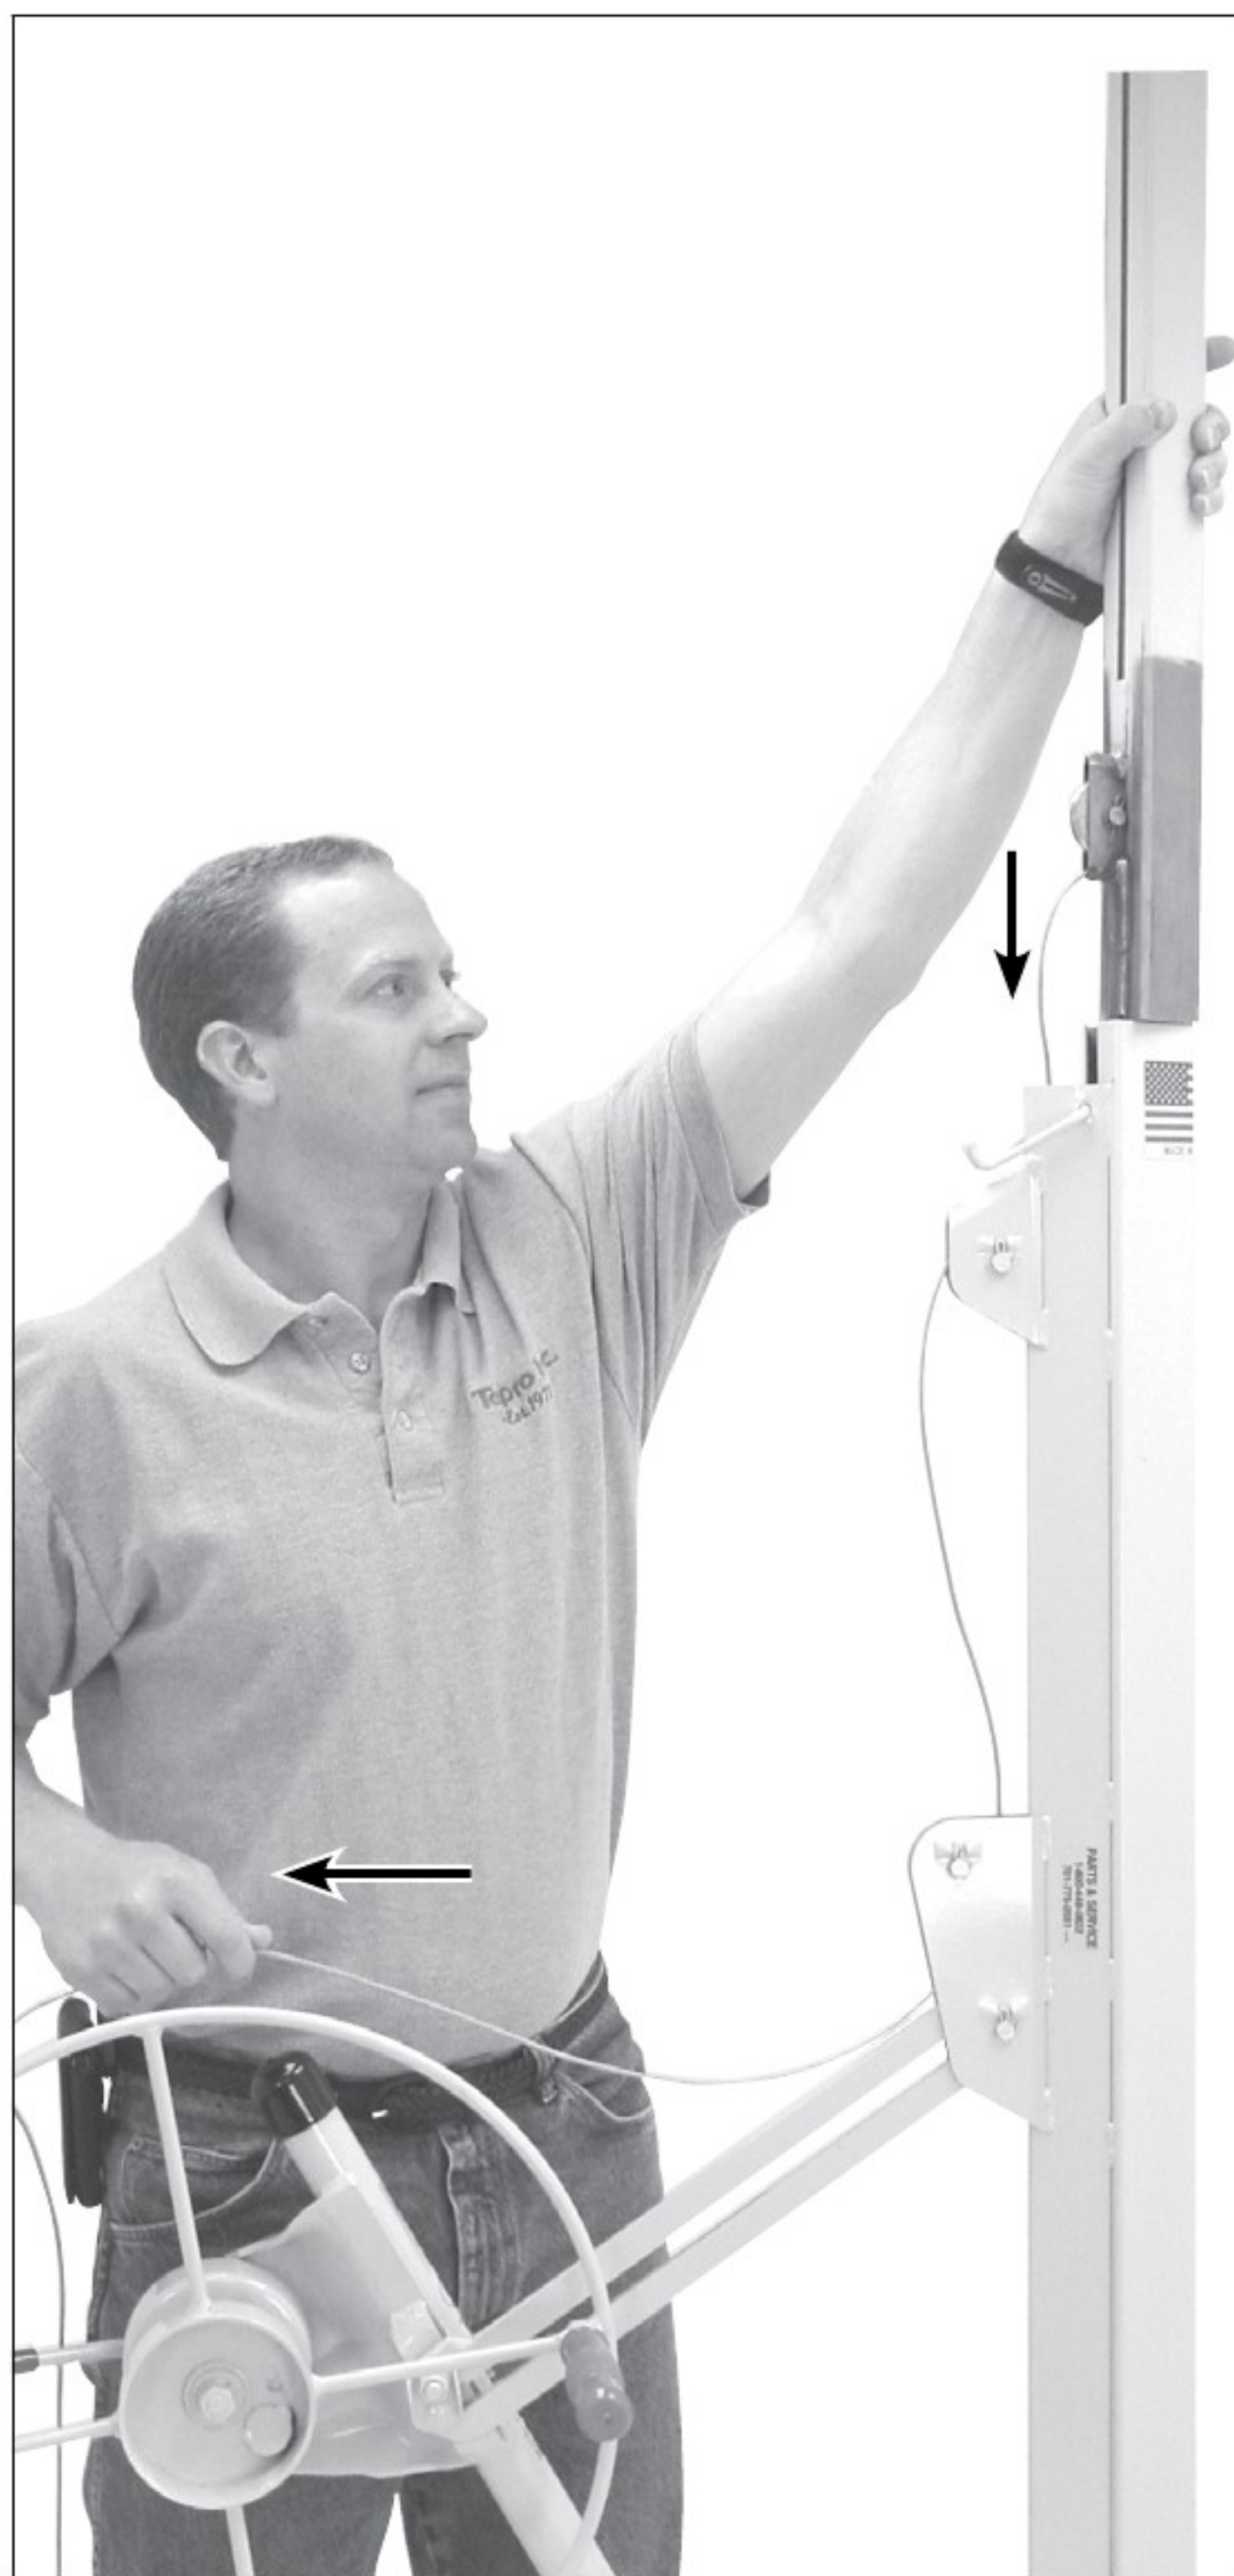
9. Pull the slack cable through the sheave pocket toward the winch and slide the telescoping sections into the frame housing. As the telescoping sections lower into the frame housing, the slack cable will be drawn back through the sheave pocket. Secure the cable correctly to the winch as shown in steps 9 - 10 on page 12
